**THE ALEXAUKEN CREEK  
WATERSHED PROTECTION PLAN  
319(h) Grant # RP05-084**

**Township of West Amwell  
150 Rocktown-Lambertville Road  
Lambertville, New Jersey 08530-3203**

**Princeton Hydro, LLC  
1108 Old York Road Suite 1  
Post Office Box 720  
Ringoes, New Jersey 08551  
908-237-5660**

**December 2010**

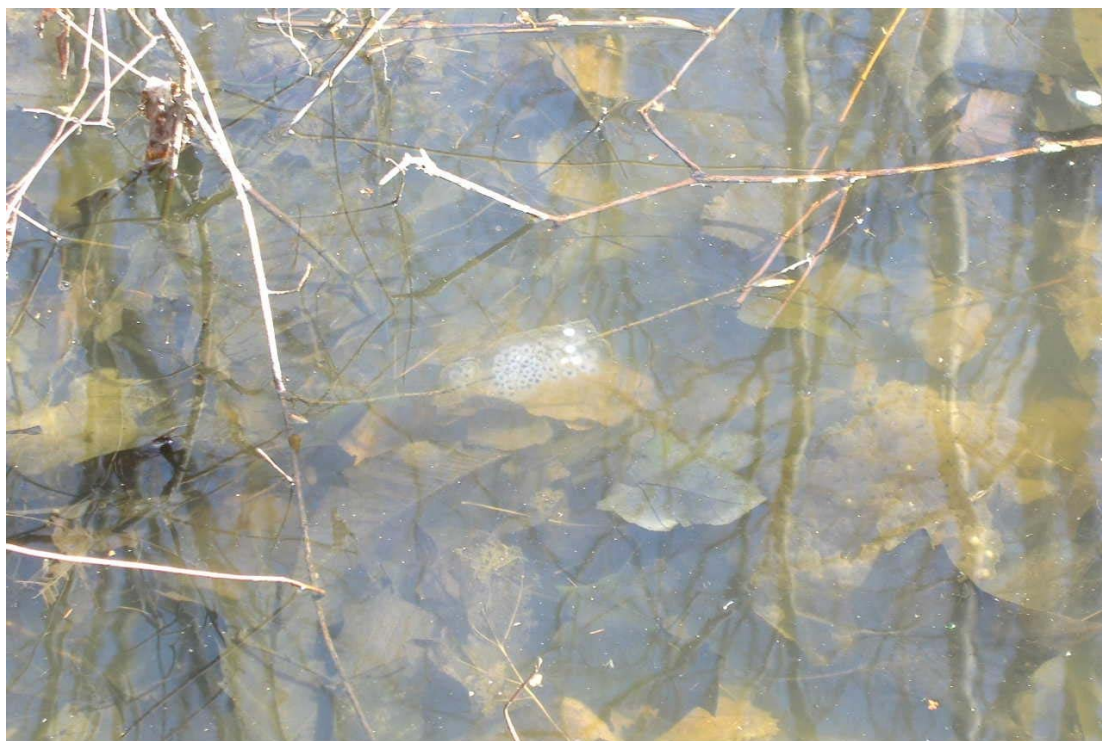
**Figure 1: Vernal Pool and *Ambystoma* sp. eggs**

Five vernal pools were identified in this quadrant's survey of exceptional resources (Figure 1). Two of these were previously certified in the Rutgers University database. The three unmapped pools were located near segment BB, and the presence of obligate vernal pool species was noted, including Wood Frog (*Rana sylvatica*) and a Jefferson Salamander (*Ambystoma jeffersonianum*). Numerous wetlands were identified in this quadrant but these seemed to largely overlap with GIS data layers.

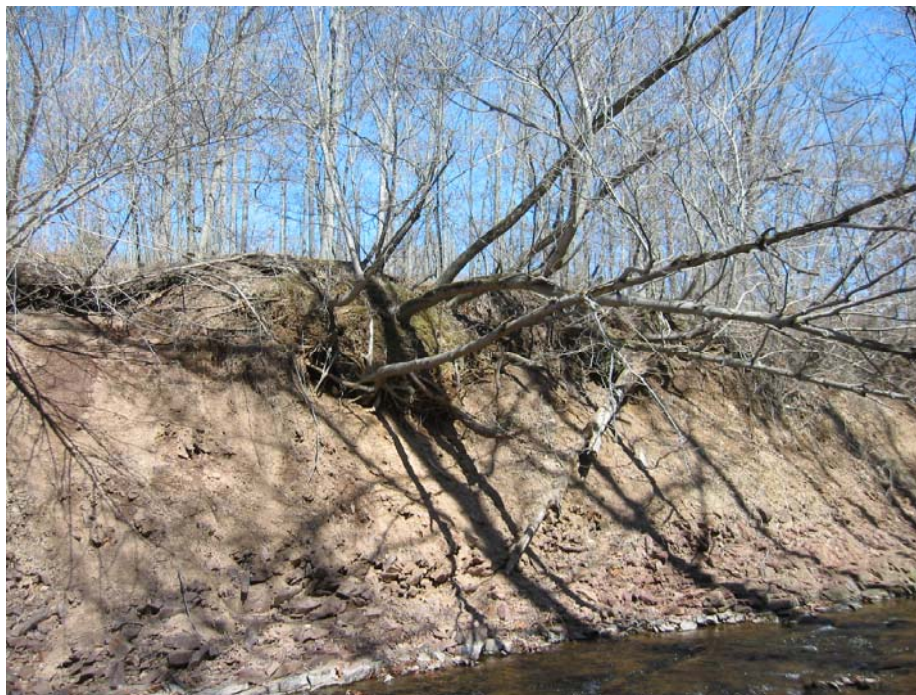
**Figure 2: Erosional Feature**

Erosion was widespread throughout this quadrant, and was noted in all seven of the surveyed segments (erosion was not assessed in segment F)(Figure 2). Stated differently, erosion was documented in 19 of the 35 reaches, and was more pervasive in this quadrant than the other three. Segment A was marked by erosional features, but these areas were mostly confined to areas adjacent to the confluence with the Delaware River; however, erosional features varied in length from 25' to 125'. Segment B was documented to have an erosional feature up to 250' in length, while erosional features in segment C were measured between 75 and 85' which is significant due to the small size of this tributary. An expansive area of erosion, 300', was identified in reach 2 of segment D. Erosion was noted in segment G as well as a lack of riparian buffer, and in segment H six instances of erosion were identified with feature lengths up to 200'. Segment I had the worst erosional problems, which were characterized as severe in reaches 2 and 3. Reach 3 in particular was very poor and the banks were so unstable in these areas that the channel condition was totally degraded according to a variety of metrics; floodplain encroachment was also noted in this area.

velocities and contributed to in-stream erosion. Segment H had numerous land uses within 50' of the banks including grazing areas, utility impacts, and road drainage discharges. Segment I was scored as the worst surveyed segment in the entire watershed. Dominant land use was agriculture and specific impairments include the dumping of trash into drainage ditches and pervasive ATV use including stream crossing. As such in-stream habitat was severely impaired and the banks were extremely unstable.

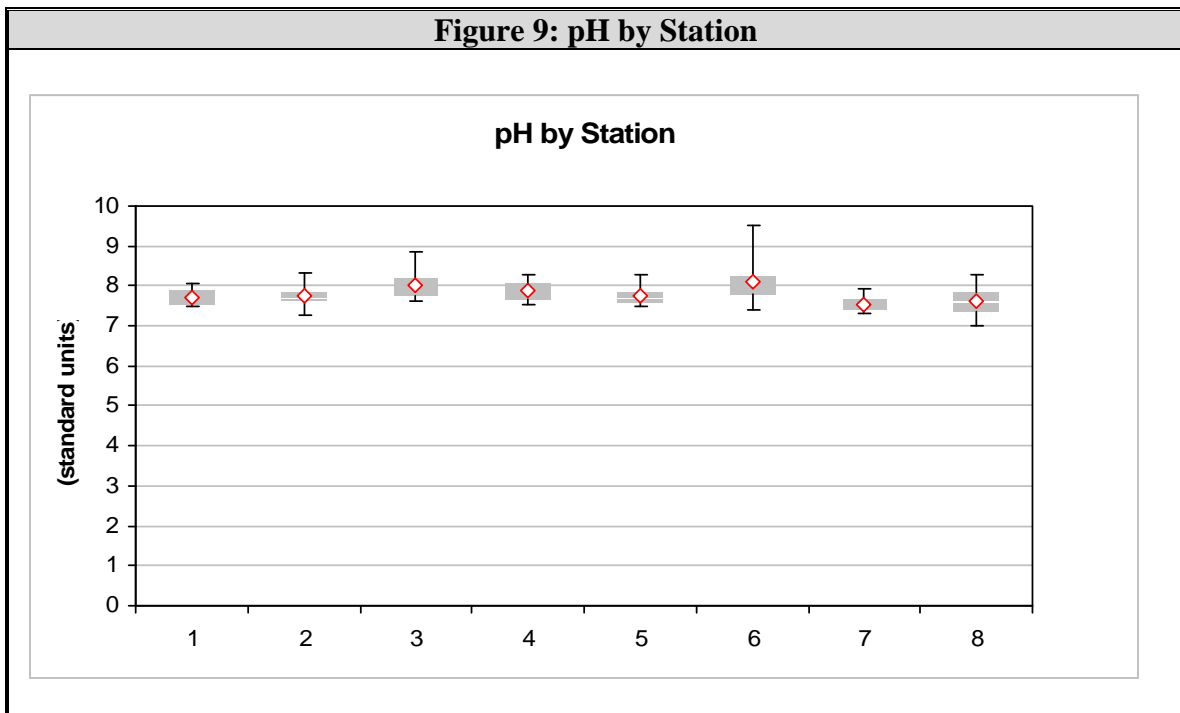
Station 6 had the highest mean pH value averaged across the entirety of the study at 8.12 followed by station 3 at 8.00 (Figure 9). Stations 7 and 8 had the lowest mean pH values. pH values in Alexauken Creek were generally acceptable and capable of supporting the typical fauna of the region. However, pH in this stream is clearly affected by photosynthetic activity. This indicates that there is some degree of nutrient pollution in the stream which allows such vigorous growth. It also indicates that inadequate canopy cover or buffering transmits too much light to the stream bed which encourages the growth of periphyton and also leads to in-stream warming.

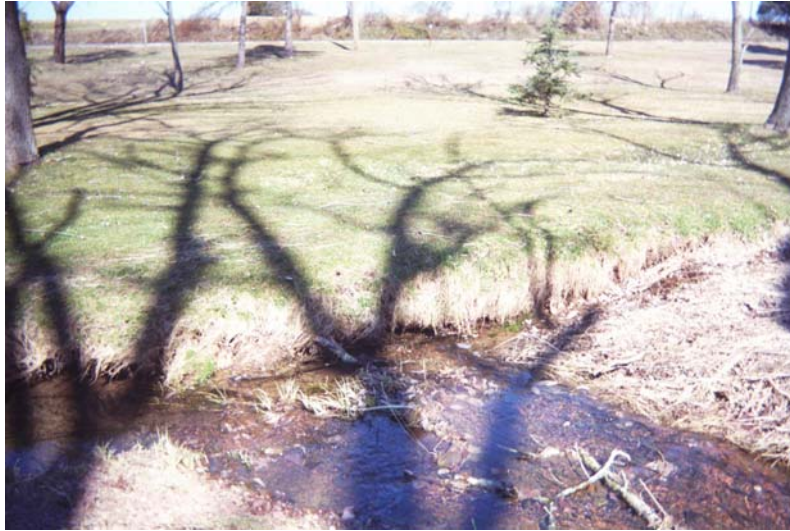
**Figure 18: Lawn Encroachment to Bank**

(Figure 18). Foremost this has led to severe bank instability often characterized by mass wasting and severe undercutting. Besides the erosion and subsequent sediment deposition of the unstable banks much of the function associated with vegetated buffers, including shading, nutrient uptake, and wildlife habitat, among others, is lost.

The ideal solution is to simply establish no-mow zones in at least a 50' buffer extending from the top of both banks where vegetation is allowed to simply grow unimpeded. In some senses this type of buffer is already stipulated in various technical regulations and municipal stream buffer and stream corridor ordinances, but existing lawns and "routine" maintenance is often granted exemption. While the establishment of no-mow zones seems simple there will certainly be some resistance to comply, especially with a 50' buffer that may comprise a large portion of maintained lawns or smaller residential lots. A compromise would be to establish as an absolute minimum a 10' riparian no-mow zone to at least establish the vegetation necessary to maintain bank integrity, decrease erosion, and provide at least some shading and other associated functions. While this should probably be adopted as ordinance and applied to existing maintained lawns, with obvious enhanced protections already in place for new development, education will probably be the strongest tool in promoting this practice and effectively conveying the benefits listed above will be crucial in this conversion.

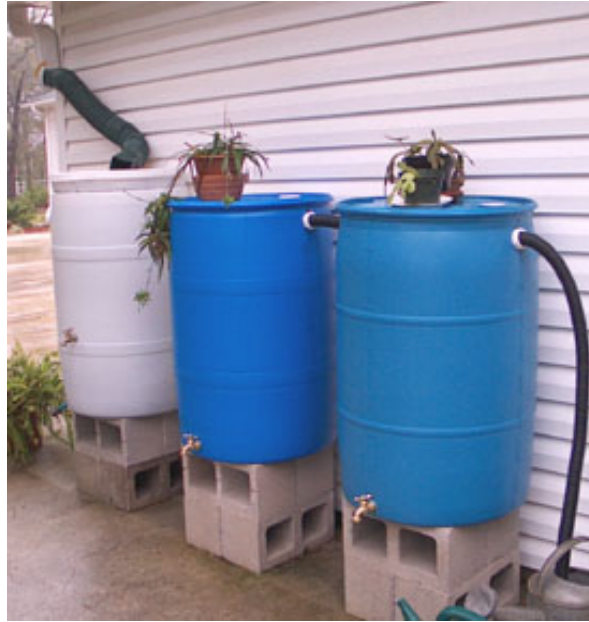
**Figure 22: Rain Barrels**

The installation of rain barrels that intercept rainfall from roof surfaces via the downspouts reduces the overall higher flows that result from increased runoff velocities from these impervious surfaces. Essentially, these barrels capture rainfall that would otherwise serve as a transport vector for nutrients and sediments (Figure 22). In addition, the water contained within rain barrels serves as a water source for uses such as residential irrigation of gardens and lawns helping to conserve water resources. Costs for rain barrels are entirely based on initial material expenditure with little in the way of upkeep. Rain barrels may be converted from recycled food barrels or purchased from many environmental retailers, in many different styles which match a home's exterior, and pre-fitted with spouts.

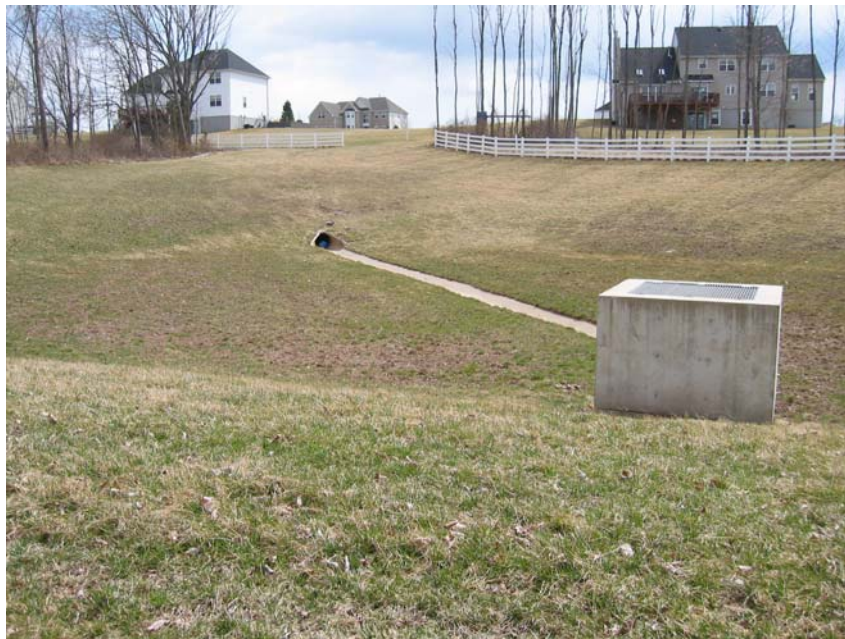
**Figure 23: Detention Basin**

This type of structural BMP still has utility, especially in larger catchments, but is reflective of an older design philosophy less concerned with treatment and volume reduction and primarily focused on peak flow attenuation. For new development it is recommended that these systems be replaced with other structural BMPs such as

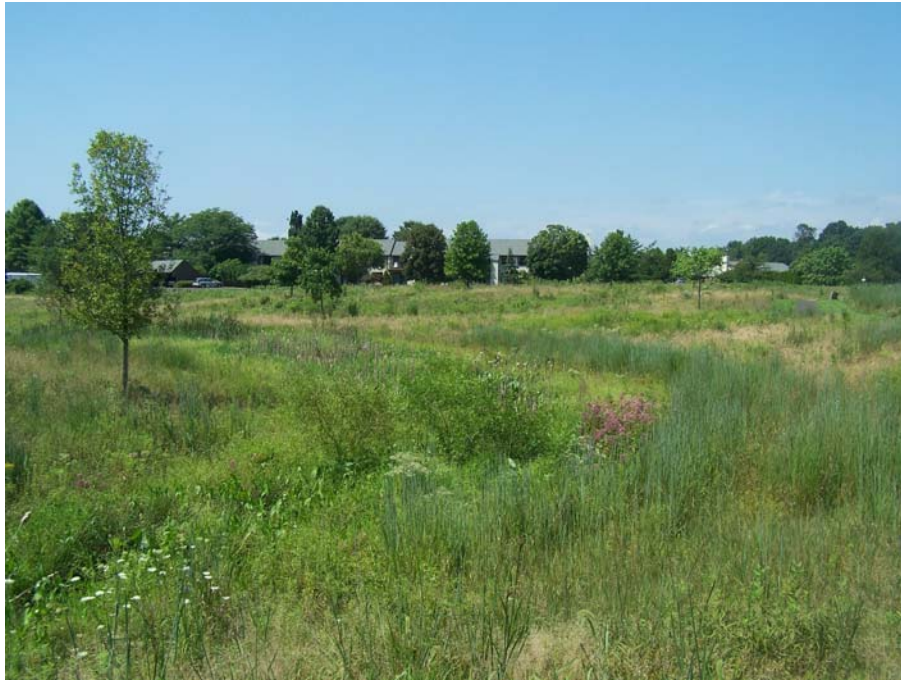
**Figure 27: Constructed Stormwater Wetland**

For the most part these systems share many of the same components including engineered berms, control structures, sediment forebays, general basin morphometry, and storage capacity. The primary difference lies in the utilization of plant materials, and secondarily in extending the linear flow path or increasing sinuosity. The extended detention basin has no specific vegetative component other than a non-native groundcover requiring mowing, while the stormwater wetland has high and low marsh communities composed of wetland plants as well as trees. The small difference, as mentioned above, provides a great array of benefits to a standard design. The image provided below is an example of a retrofitted detention basin, which is nearly indistinguishable from a natural wetland (Figure 27).

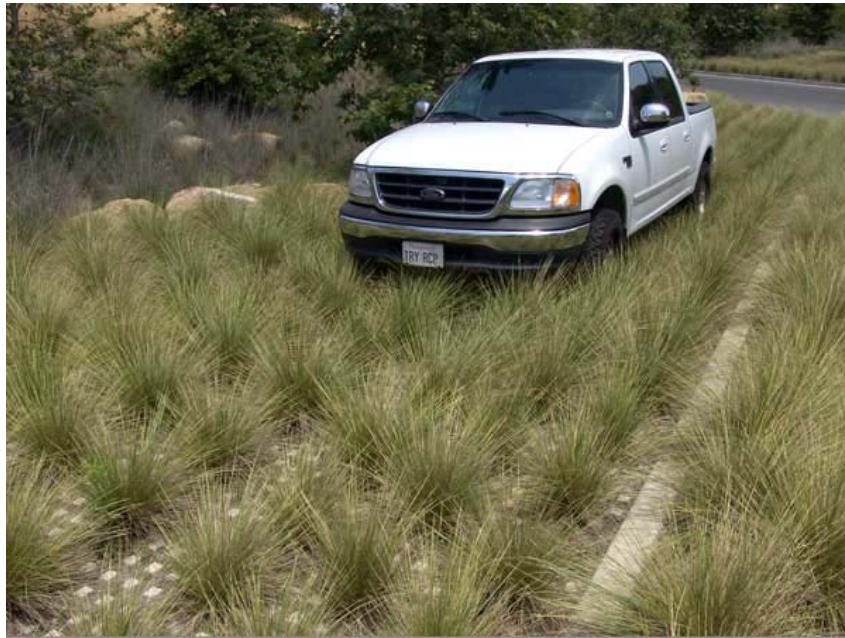
**Figure 33: Turf Blocks**

but systems with storage beds also have the capability to capture solids with an adopted TSS removal rate of 80%. There are generally three types of systems: porous pavement, permeable pavers with storage beds, and permeable pavers without storage beds. Porous pavement describes porous asphalt and pervious concrete over a storage bed. Permeable pavers describes different individual, usually pervious pavers that can be concrete, brick, cobble, crushed aggregate, natural stone, or unit pavers that infiltrate through the void spaces or at the joints of the pavers. These systems may or may not have subsurface storage, but those without have a reduced capability to infiltrate larger storm events and may still generate runoff though at a reduced rate. Pavers can also be turf block designs that incorporate load bearing surfaces and permeable soil plant with grasses to provide additional infiltration, solids removal, and evapotranspiration. The images below show details for permeable pavement and installed turf blocks (Figures 32 and 33).

Maintenance requirements vary between the systems, but can be relatively intense. Permeable pavement in particular requires routine maintenance with seasonal sweeping and high pressure washing to remove captured solids and maintain open pore spaces. In paver systems the burden is reduced but those with integrated vegetation require care of the plant materials. Snowplowing, which is a concern in the Alexauken, must be conducted with care in paver systems to avoid displacement of the pavers. As with other infiltration devices site soil conditions can be a primary determinant of their applicability and they cannot be located where there is a chance of hazardous materials release that could contaminate the groundwater.

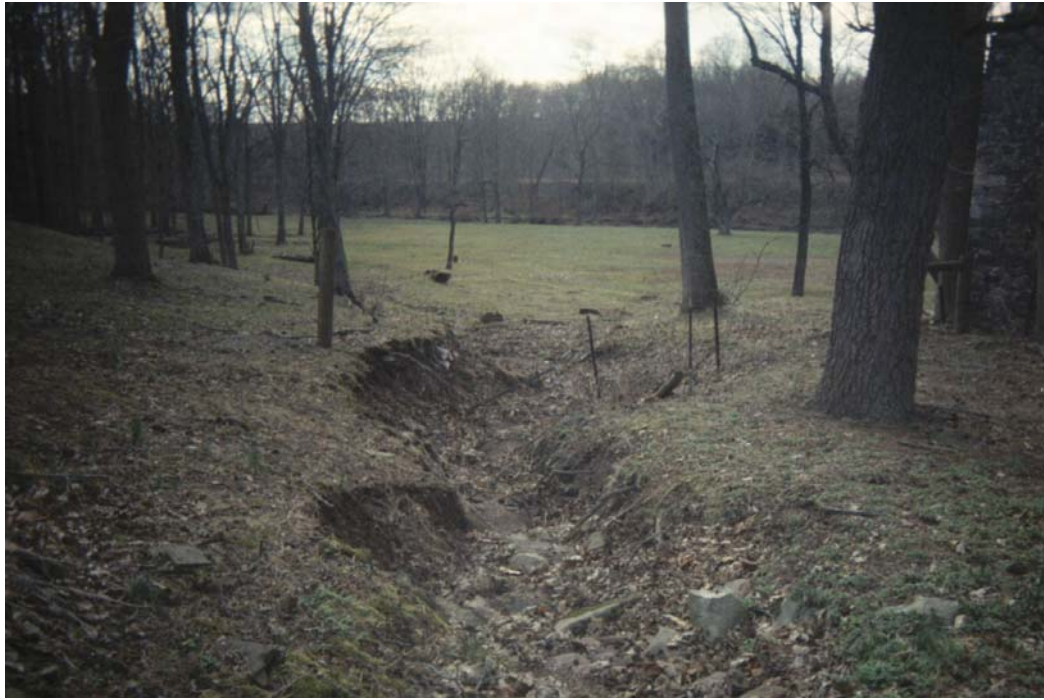
**Figure 35: Vegetated Swale Candidate Site**

The simplest design is the grassed swale, which is simply a grass lined swale constructed in maintained lawn space. Because the grass is typically mowed in this design, the amount of treatment in this system is quite limited and is generally valuable only for pre-treatment to other BMPs and in limiting erosion. A vegetated swale, sometimes referred to as a dry swale, has a similar channel morphometry, generally trapezoidal with modest slopes, but is planted with a variety of native plants including trees to provide mechanical filtration and maintain channel stability. These systems may also incorporate very small check dams within the channel to reduce velocities and provide short term detention. Figure 34 illustrates a conceptual design of a vegetated swale and a location within the Alexauken watershed where such a design may be implemented (Figure 35). Wet swales are similar to dry swales but also incorporate small permanent pools and function more closely to a series of linked wetland cells.

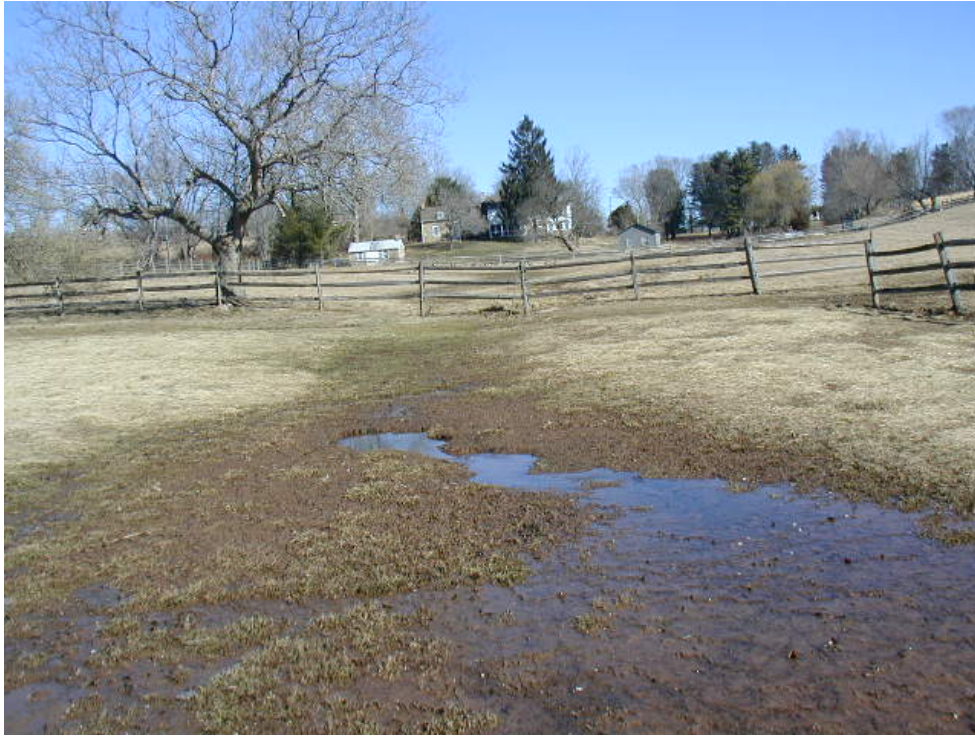
**Figure 37: Vegetative Filter Candidate Site**

Vegetative filters are related to swale features but are designed to treat sheet flow and not concentrated flow in a channel. As such they are oriented perpendicular to the flow path and parallel to elevation contours on a slope, generally less than 5% grade. In some senses vegetative filters mimic the function of riparian buffers and native forests. The figure below (Figure 36) illustrates the schematic of a vegetative filter while Figure 37 shows a candidate site.

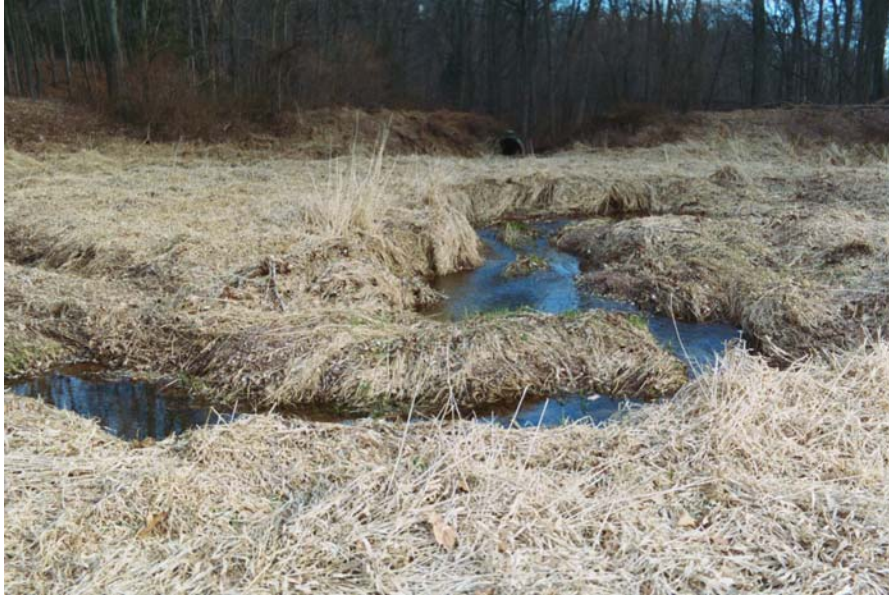
**Figure 39: Planting Candidate Site**

Willow (*Salix nigra*), Box Elder (*Acer negundo*), Green Ash (*Fraxinus pennsylvanica*), and River Birch (*Betula nigra*). Candidate sites for simple planting would include those with mild erosion and a lack of riparian vegetation (Figure 39).

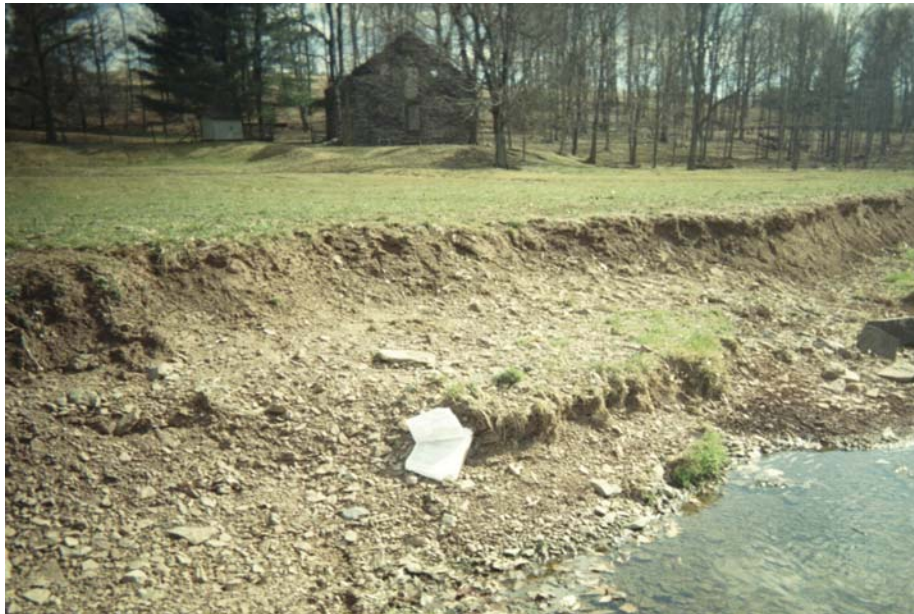
**Figure 42: Bank Grading Candidate Site**

The practical implementation of these types of bank stabilization measures is generally low to moderate. Flood Hazard Area Rules may require at least general permits for some of these activities, and engineering consultation will probably be required for at least grading activities.

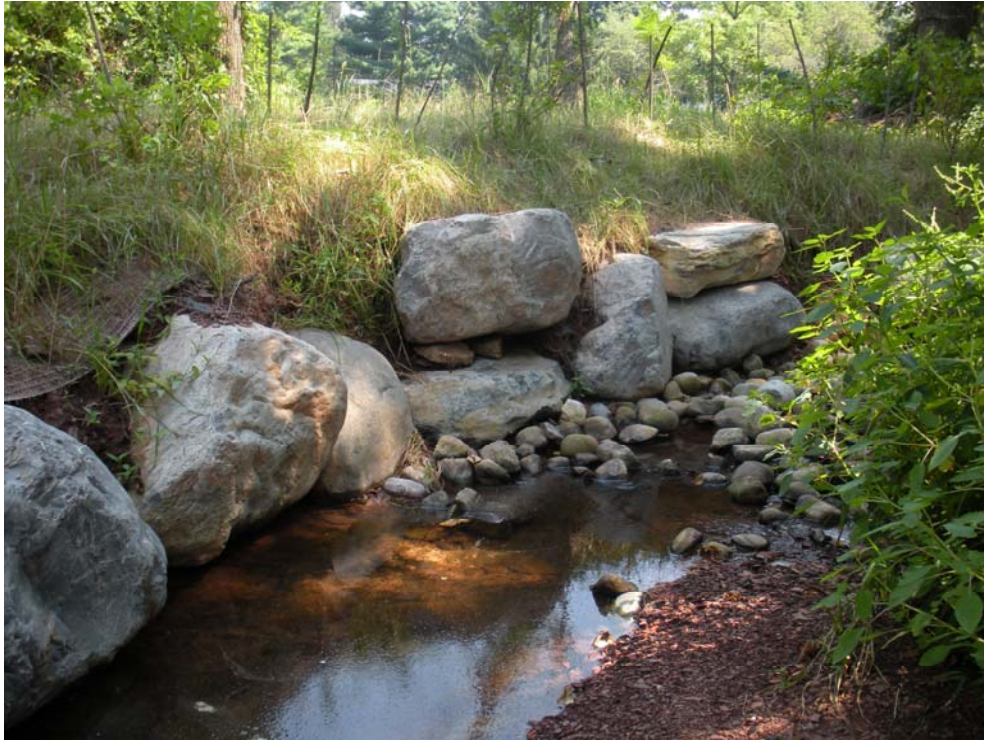
**Figure 44: Boulder Toe Protection**

Boulder toe protection designs function similarly to rootwad to provide bank stability and prevent erosion along outside bends utilizing large boulders instead of trees. In addition to protecting the toe of the bank the boulders may be stacked as necessary to provide additional armoring higher up the bank. Design specifications are generally mutable but the resistive boulders should be placed to achieve approximately 50% embedment. Bank grading and the placement of fill material behind the boulders is usually encouraged. The material behind the boulders is usually planted with woody vegetation. A boulder toe design is shown below (Figure 44).

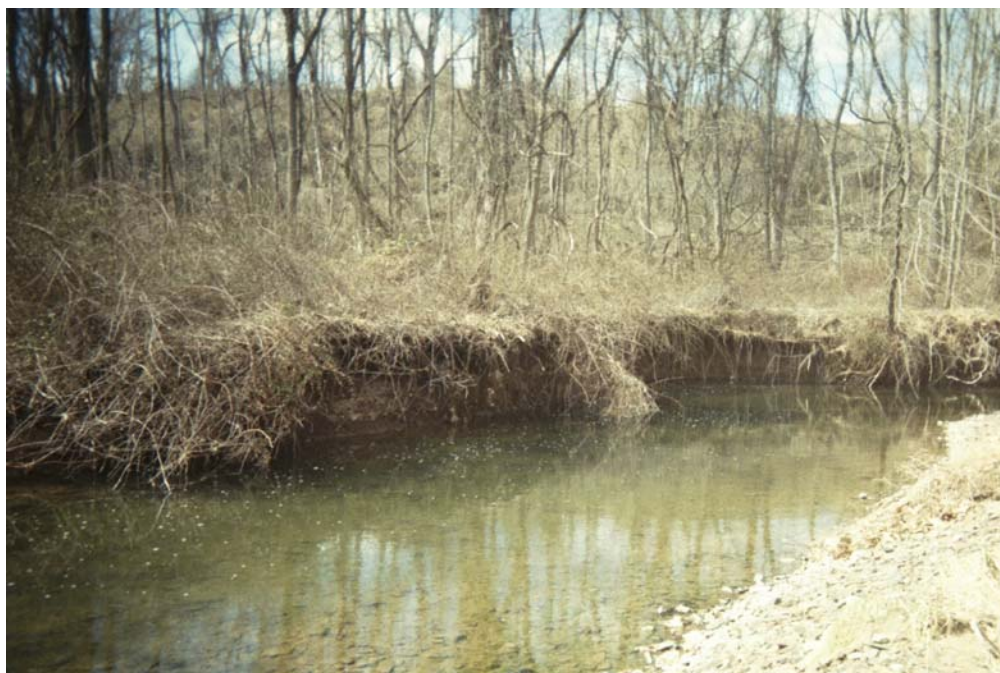
**Figure 48: Flow Deflection Candidate Site**

The image below (Figure 48) would likely be a good site in the Alexauken watershed to implement a flow deflection solution. Such a design would deflect the heaviest flows

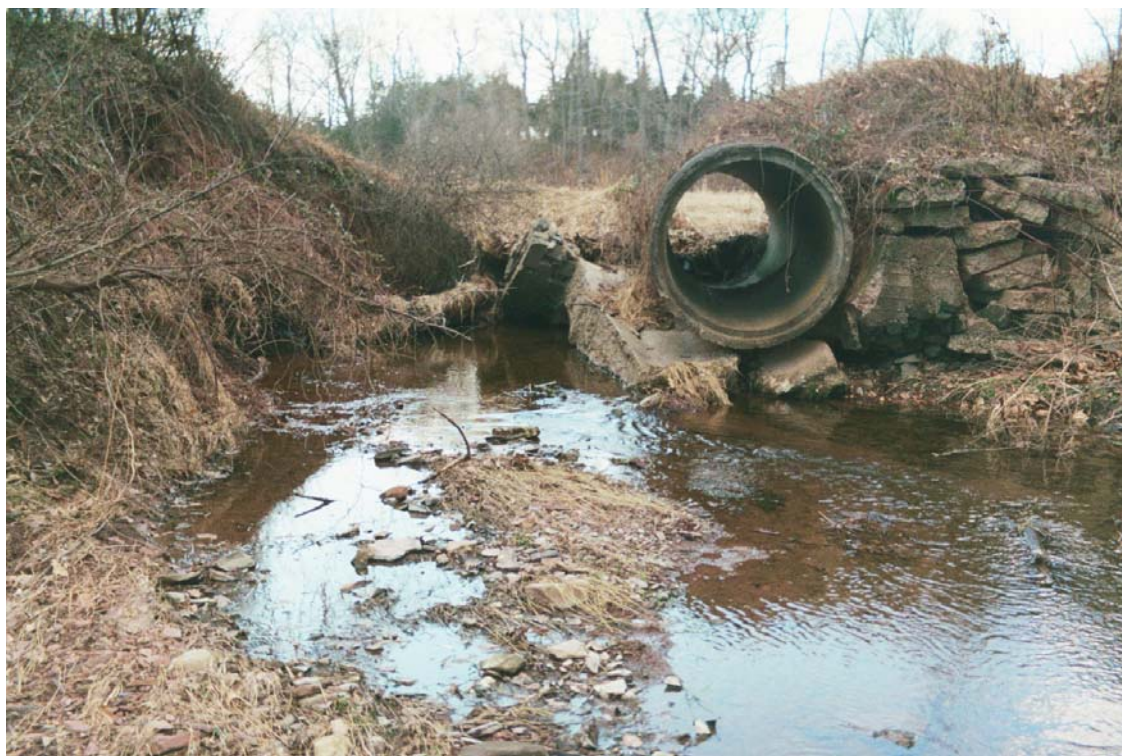
**Figure 51: Grade Control Candidate Site**

The removal of the stream obstruction located in the watershed (Figure 51) would certainly require a grade control structure post-removal, likely a cross vane. In this setting a cross vane would stabilize any head cut, connect the hydraulic jump above and below the obstruction, and align flow through the center of the channel.

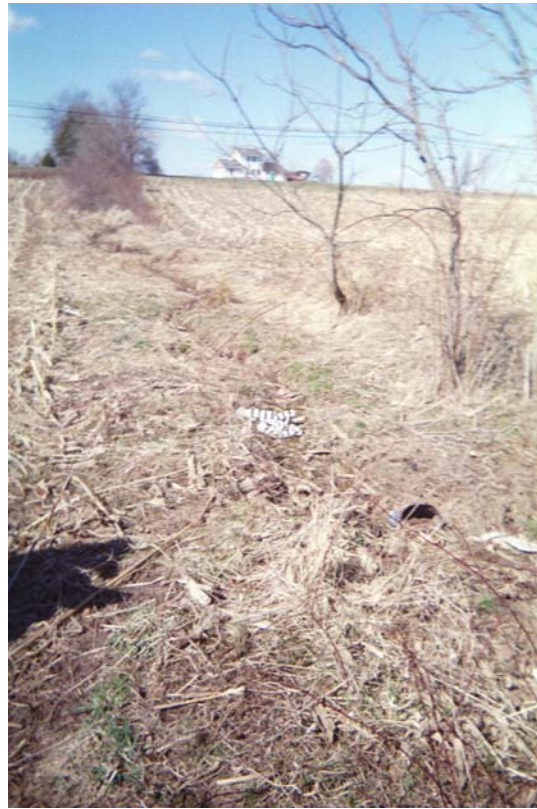
**Figure 52: Eroded Ditch**

Grassed waterways and diversion methods should be strongly considered for implementation throughout the watershed. As a result of topography many of the fields in the watershed are sloping and are situated close to the tributary network. As such, management of runoff and water in general is a concern in these fields, and many drainage features discharge directly to adjacent tributaries. Because of the direct discharge field drainage features have an even greater potential to deliver eroded sediments directly to the stream. In the image provided below (Figure 52) a small drainage ditch located in the watershed is showing signs of erosion and the in-filled outfall at the bottom is clearly blocked, minimizing the capacity to effectively manage runoff in the field and contributing to erosion and sedimentation issues.

The implementation of grassed waterways would be ideal for this situation. Like vegetated swales discussed in the structural BMP section above, the grassed waterway is merely an agricultural application of the same principles used in agricultural fields. Namely, grassed waterways utilize a permanent groundcover to provide surface stability to prevent erosion and the vegetative filtering and removal of suspended sediments in directed runoff. The following detail, taken from a Princeton Hydro engineering plan shows a schematic view of a grassed waterway with tributary diversion situated on the contour (Figure 53). While additional diversions are not required, especially if there is

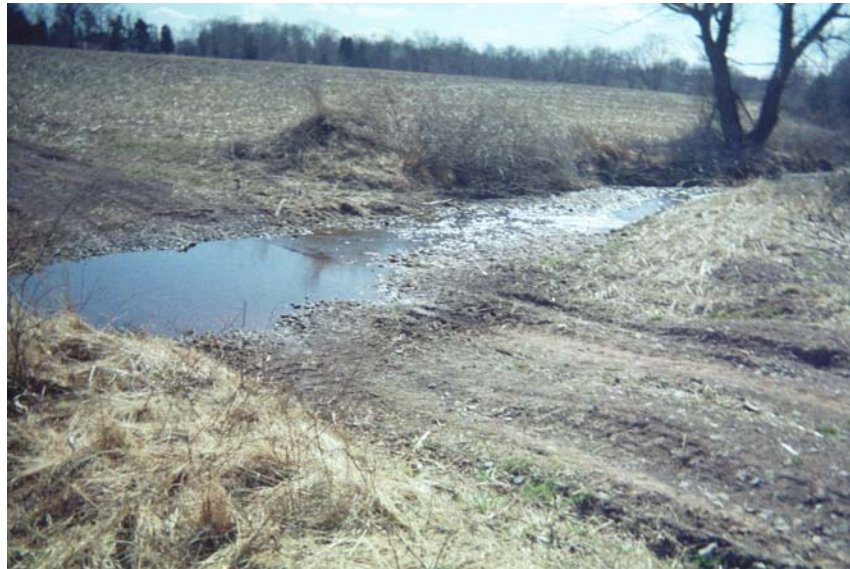
**Figure 54: Unimproved Agricultural Stream Crossing**

Finally, stream fencing and crossing improvements should be considered to limit in-stream erosion, solids loading, and bank instability. While livestock access to tributaries in the watershed seems to be limited, agricultural crossings are fairly common and few are improved structures, as illustrated in Figure 54, a typical agricultural stream crossing in the watershed.

There are a variety of simple fixes, one of the most popular being the hog panel stream crossing with gravel driveways, and where livestock cross, fencing (Figure 55). These solutions can significantly reduced localized bed instabilities, which can result in the formation of migrating head cuts and erosion upstream, and solids loading to the stream.

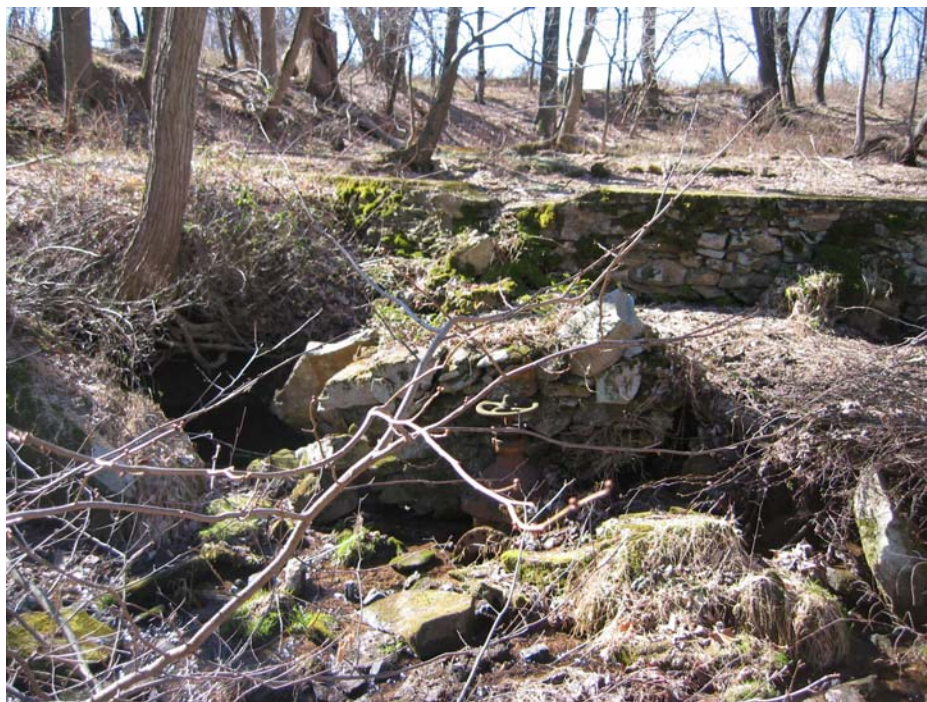
**Figure 56: Failed Impoundment**

The challenging part of dam removal may be the restoration process. Typically, after the removal of the obstruction bank and bed stabilization measures are implemented, as discussed above in the bed and bank stabilization section. This may include flow deflection devices, toe protection and bank armoring, and grade control. Grade control, provided by a cross vane or an engineered rock riffle is usually a crucial component and is installed to prevent the formation of headcuts and limit erosion. Bank plantings and riparian buffering are also encouraged to convert the riparian corridor to more natural function.

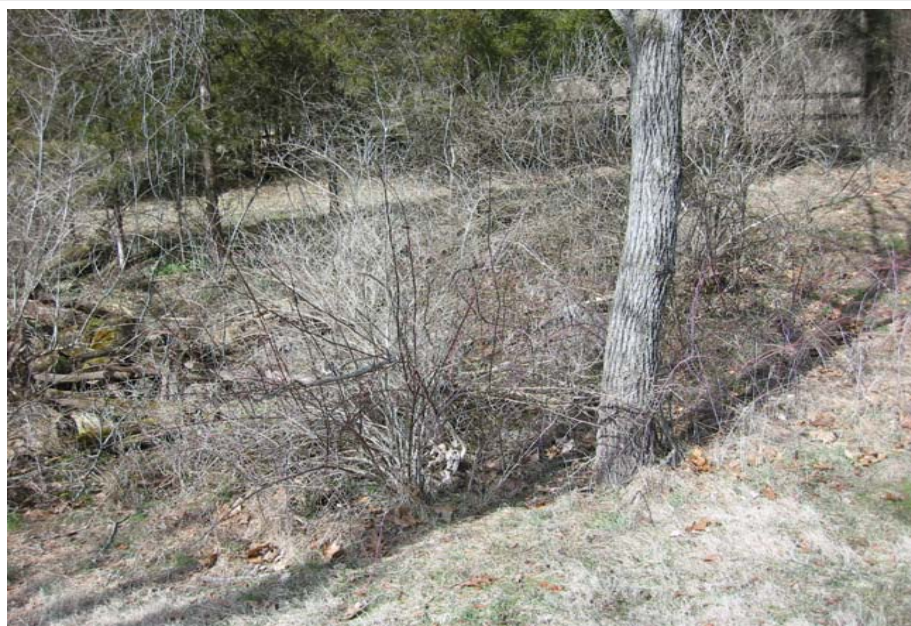
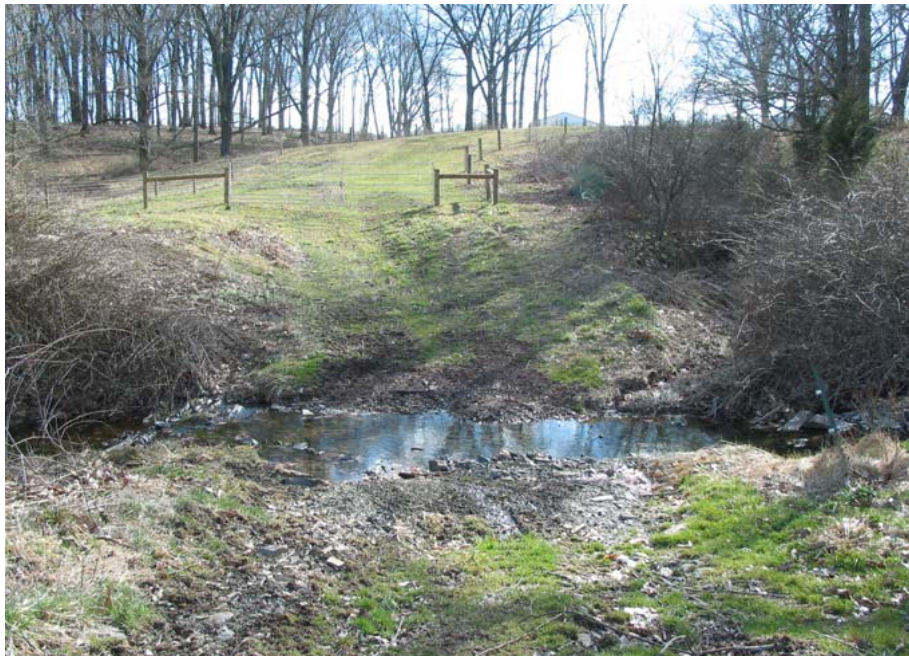
## **#13: Alexauken Creek Tributary Channel Improvements**

### **Segment K, Reach 2**

- Install a hardened agricultural crossing such as a hog panel crossing and stoned driveway
- Maintain manure management areas away from riparian corridor
- Remove obstruction, stabilization likely not needed

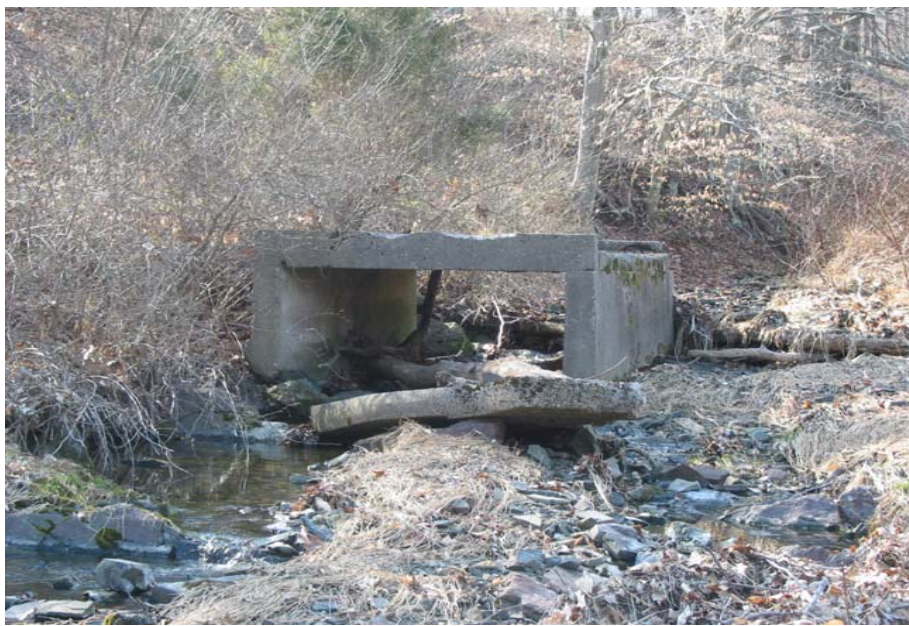
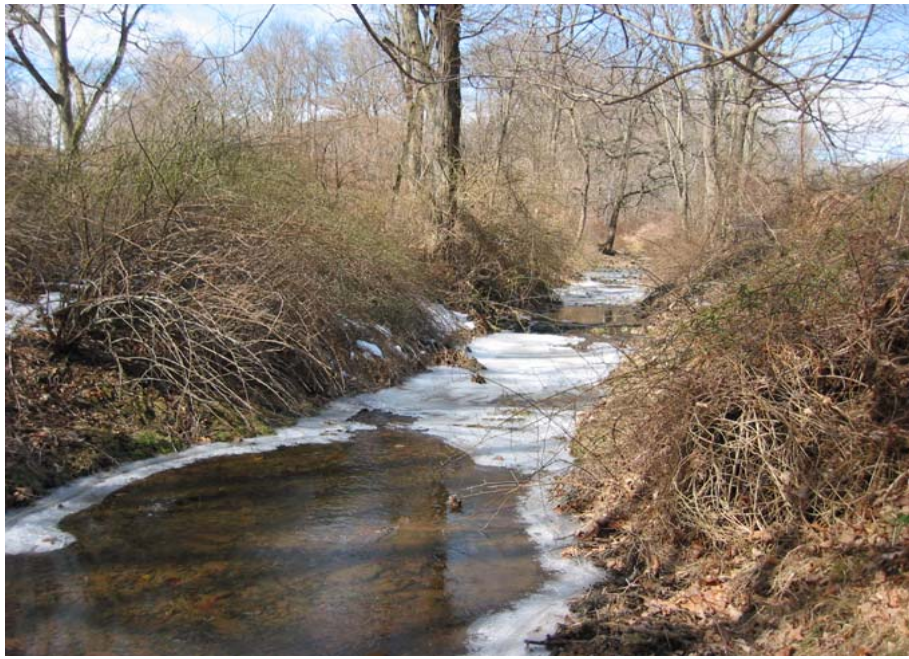
## **#14: Alexauken Creek Tributary Buffer Enhancement**

### **Segment K, Reach 3**

- Mechanical or chemical removal of invasive species
- Riparian buffer enhancement using native vegetation to enhance wildlife habitat value and other services

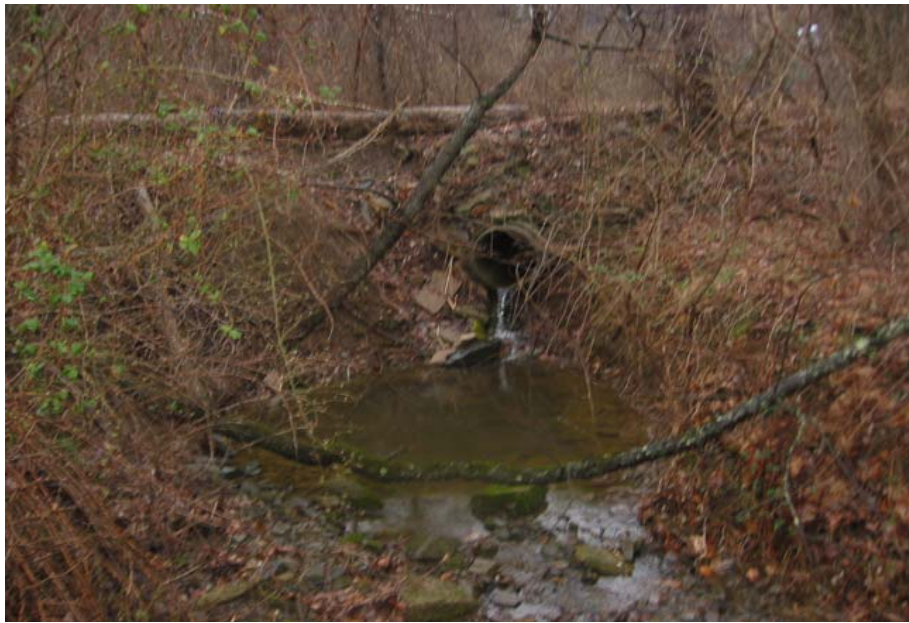
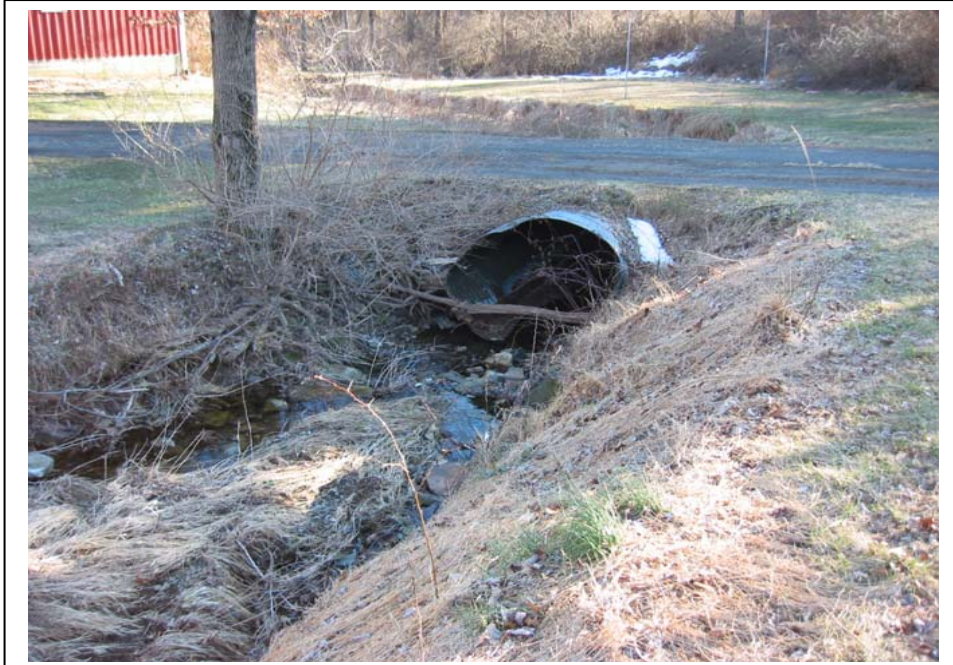
## #16: Alexauken Creek Tributary Bank Stabilization

### Segment K, Reach 7

- Establish a no-mow zone and plant shrubs along the swale to stabilize bank and prevent further deposition of bank materials in channel

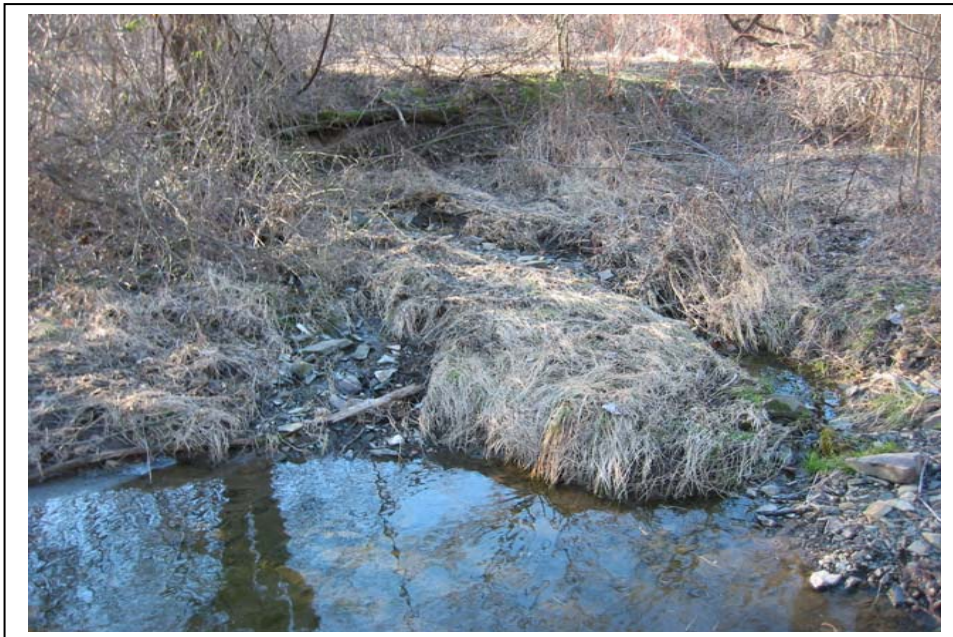
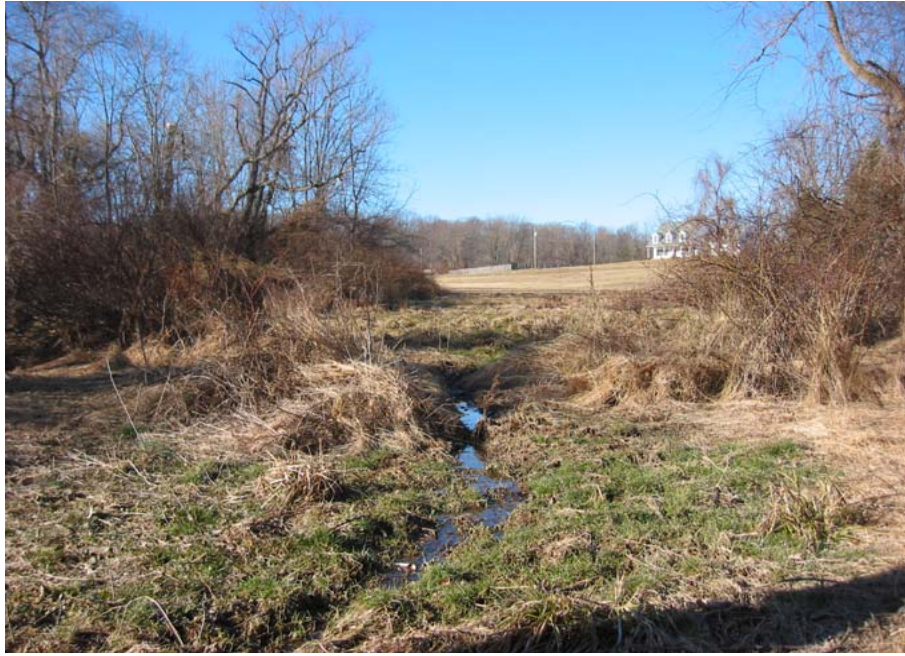
## **#17: Alexauken Creek Tributary Wetland Enhancement**

### **Segment K, Reach 8**

- Remove invasive species chemically
- Plant wetland vegetation, especially herbaceous species
- Maintain no-mow zone around wetland area
- Limit disturbance in wetland

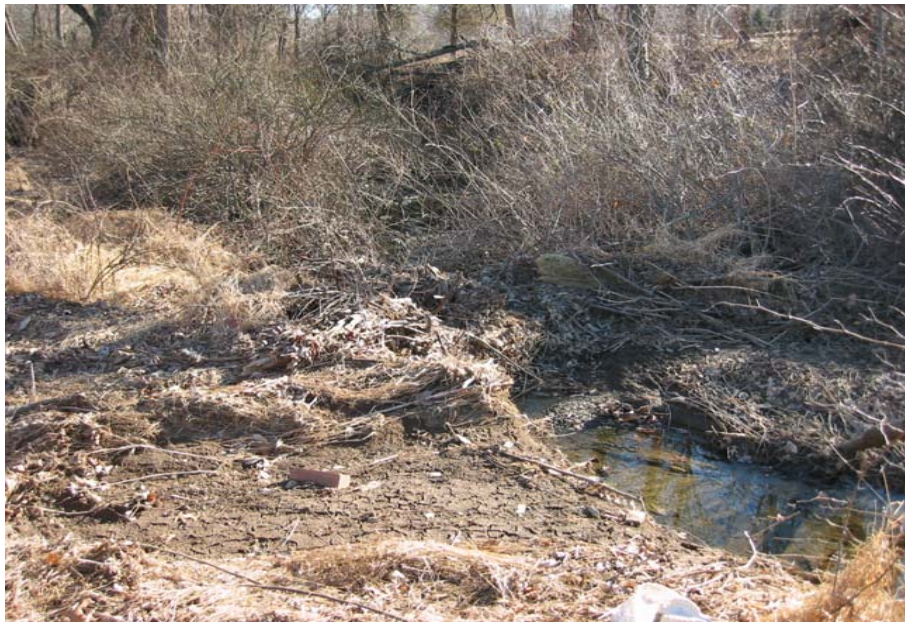
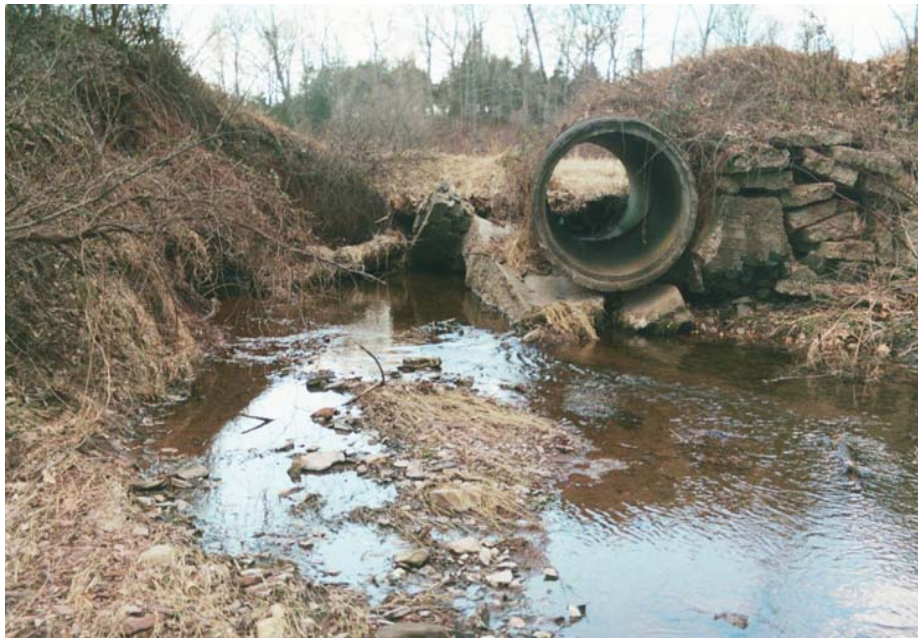
## #18: N. Branch Alexauken Creek Tributary Obstruction Removal

- Bank erosion
- Migrating head cut
- Debris and potential passage barrier
- Degraded riparian zone

- Remove obstruction
- Grade banks and vegetate
- Establish grade control such as cross vane
- Enhance buffer above through no-mow zone or planting

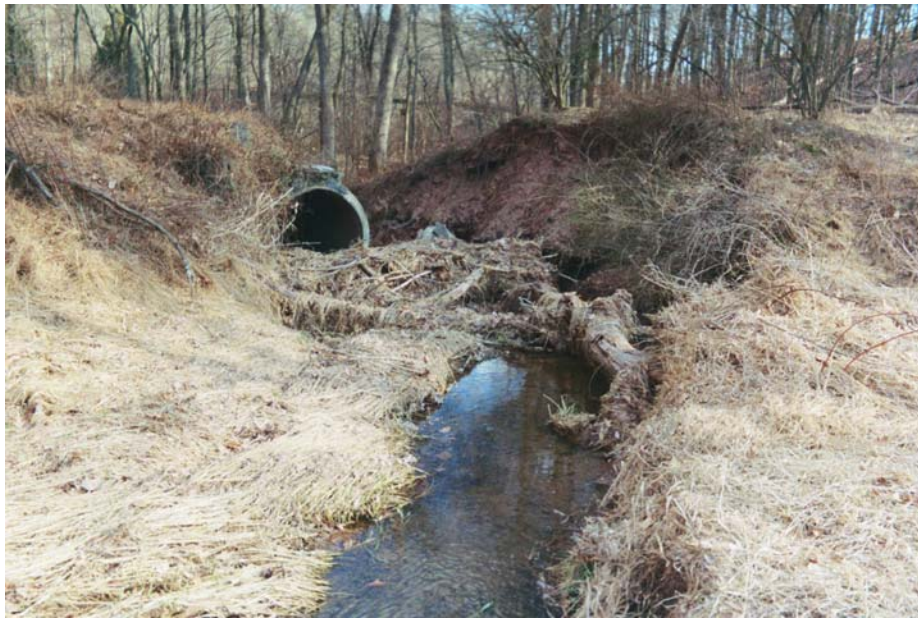
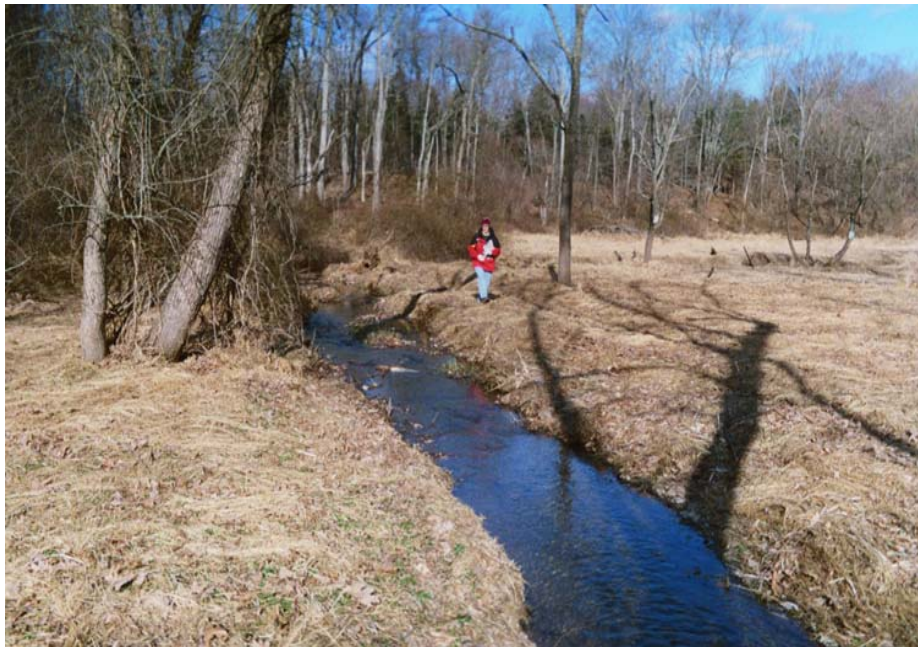
## #19: N. Branch Alexauken Creek Tributary Buffer Enhancement

- Degraded buffer
- Lack of adequate shading
- Invasive species
- Sedimentation

- Riparian buffer enhancement with removal of invasives and subsequent planting of three vegetation types: herbaceous, shrub, and tree
- Establish canopy
