**THE ALEXAUKEN CREEK  
WATERSHED PROTECTION PLAN  
319(h) Grant # RP05-084**

**Township of West Amwell  
150 Rocktown-Lambertville Road  
Lambertville, New Jersey 08530-3203**

**Princeton Hydro, LLC  
1108 Old York Road Suite 1  
Post Office Box 720  
Ringoes, New Jersey 08551  
908-237-5660**

**December 2010**

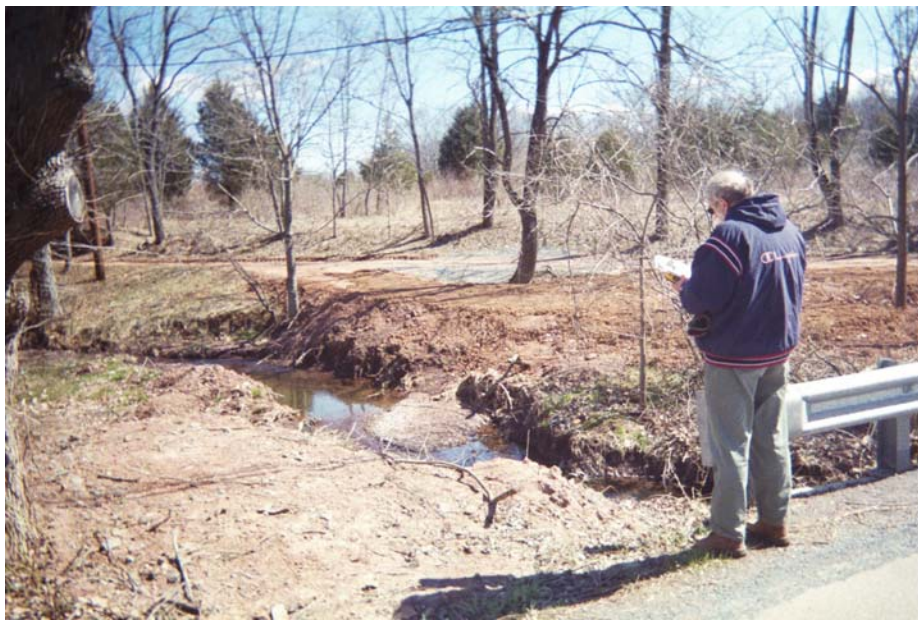
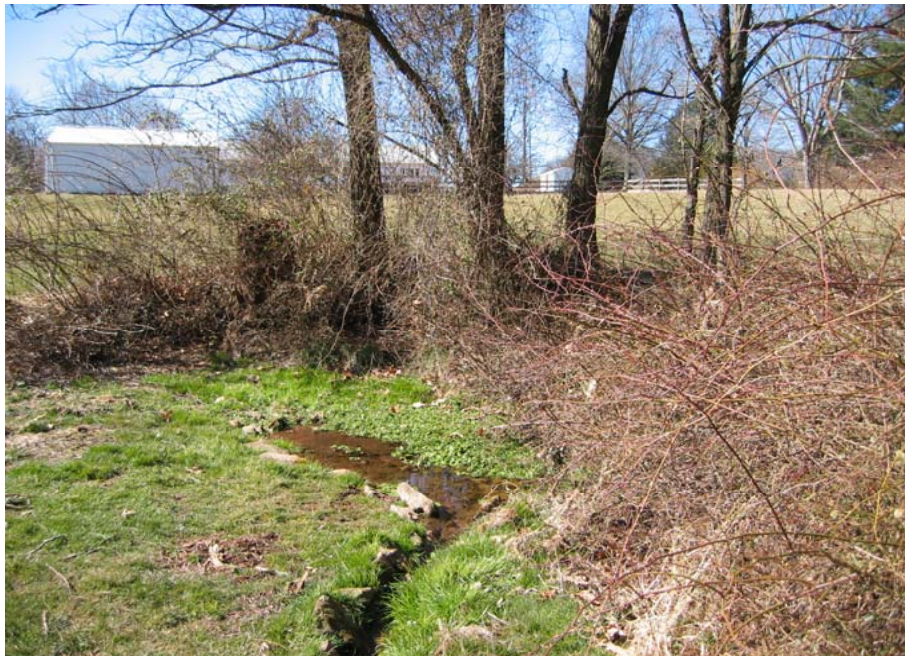
## #25: N. Branch Alexauken Creek Tributary Wetland Enhancement

- Degraded wetland
- Minor erosion
- Invasive species

- Establish a no-mow zone or riparian buffer enhancement around margin of wetland
- Utilize existing native vegetation as a component of protection
- Remove invasive vegetation

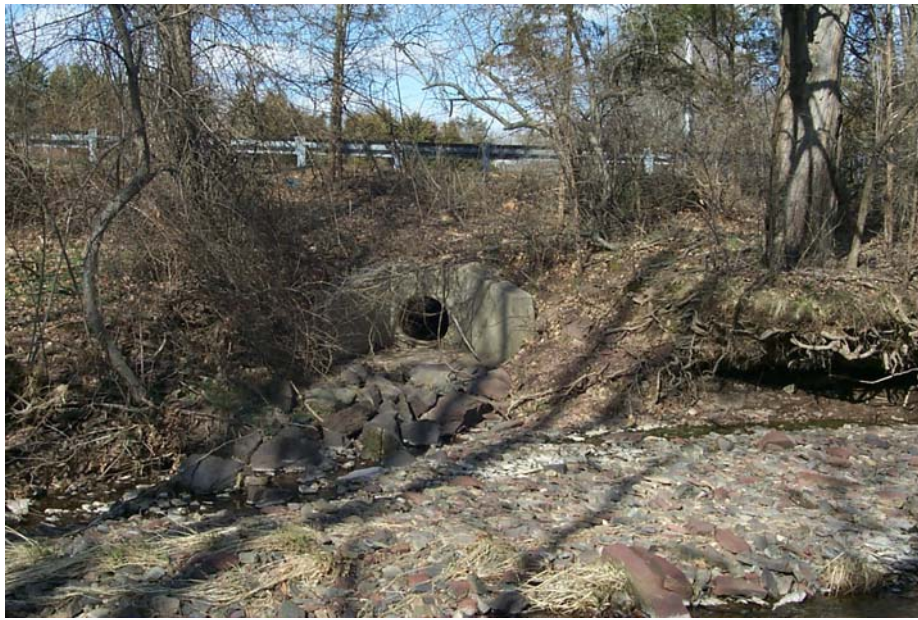
## #31: Alexauken Creek Stormwater Infrastructure

### Segment U, Reach 7

- Routine maintenance of catch basin at upper end of pipe
- Retrofit catch basins for increased pollutant removal using filter media, vortex capture, or other NJCAT certified designs

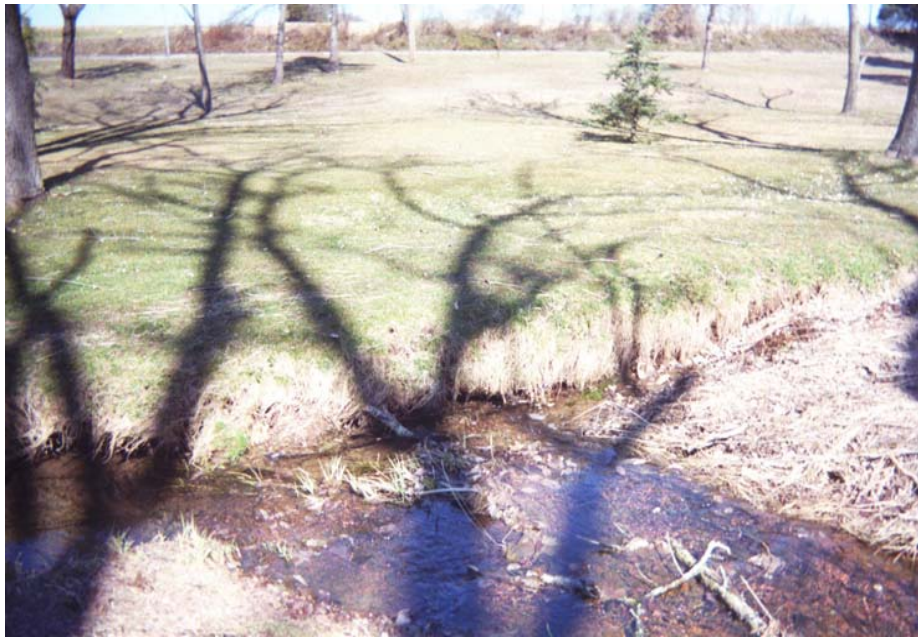
### **#34: Alexauken Creek Tributary Buffer Enhancement**

#### **Segment W, Reach 5**

- Establish no-mow zone
- Transition to riparian buffer planting over time
- Utilize existing trees and other vegetation where appropriate
- Boulder toe protection where necessary

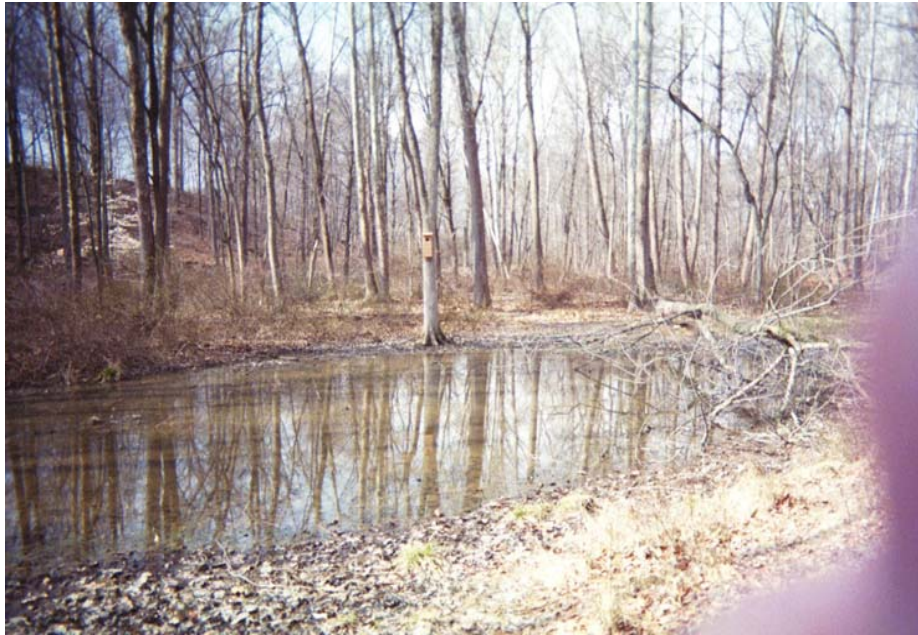
### **#35: E. Branch Alexauken Creek Vernal Pool**

#### **Segment X, Reach 2**

- Public education of outstanding ecological value of vernal pools
- No disturbance of site
- Establishment of increased field border width at top of hill

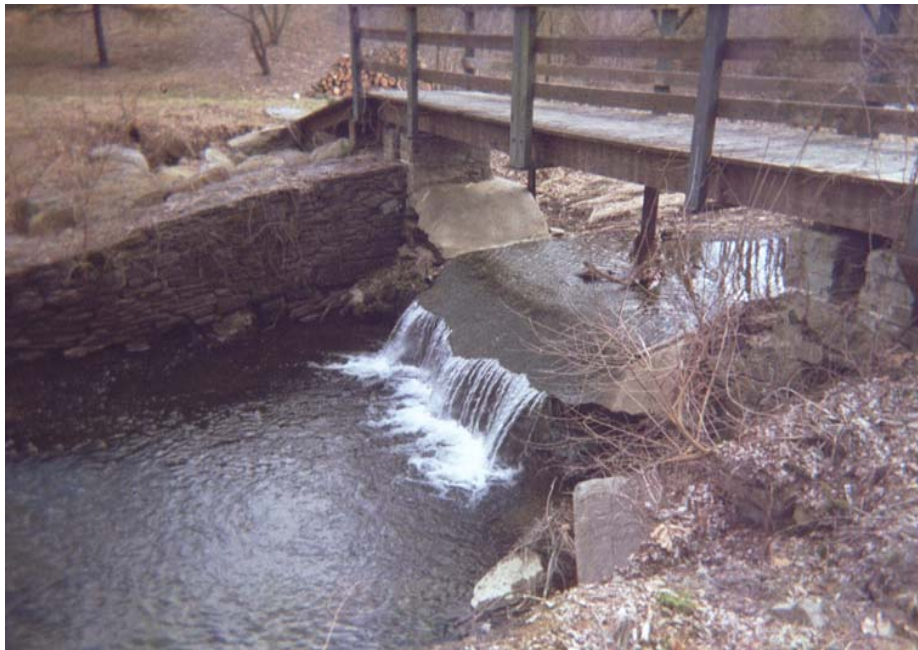
## **#36: S. Branch Alexauken Creek Obstruction**

### **Segment AA, Reach 1**

- Decrease hydraulic jump distance through the installation of small cross vanes in series

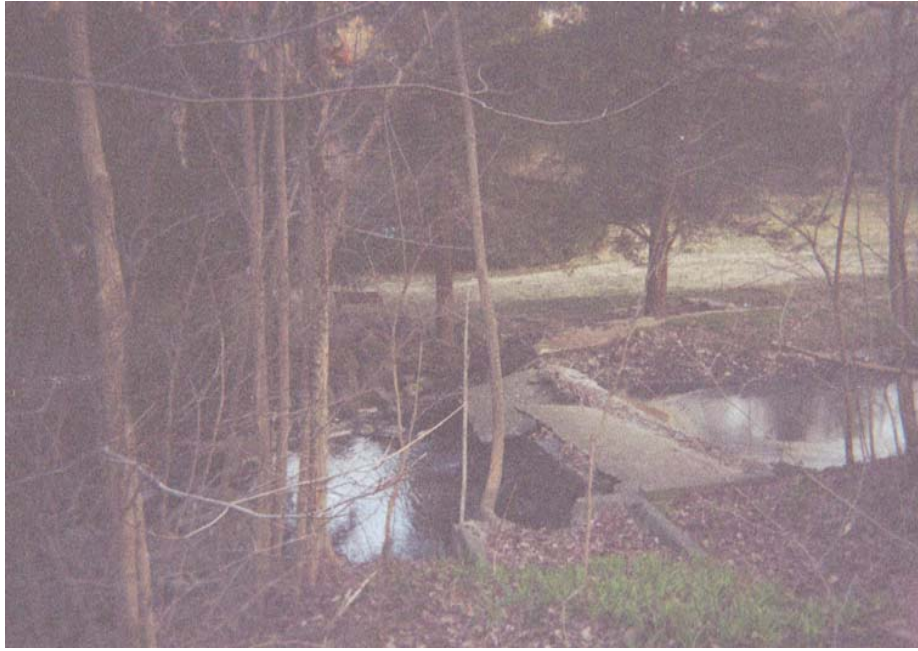
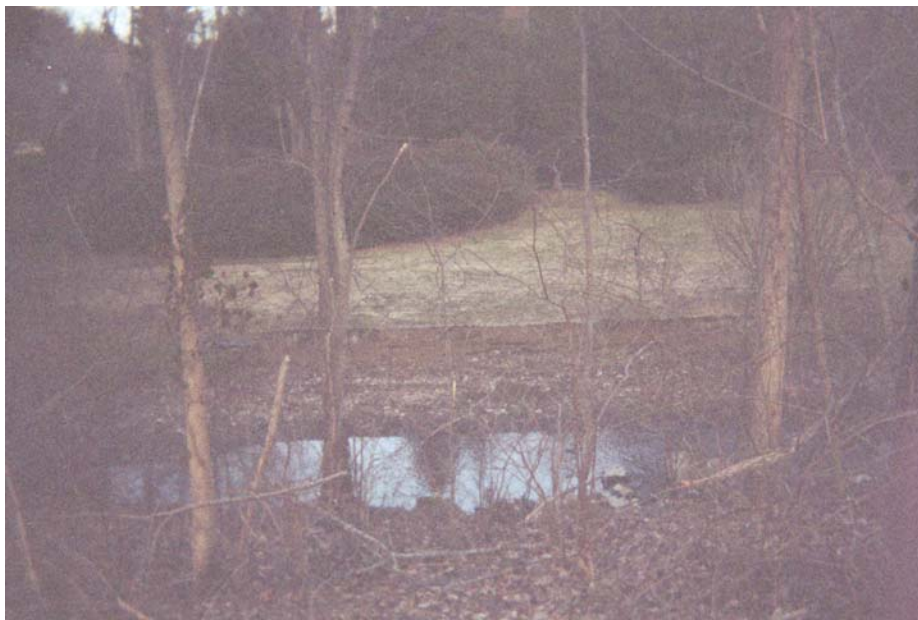
## **#37: S. Branch Alexauken Creek Obstruction**

### **Segment AA, Reach 2**

- Barrier to fish passage
- Failed dam may contribute to erosion when breached
- Lack of shrub layer
- Temperature impairment

- Remove obstruction in stream
- If necessary install grade control
- Plant shrubs along bank

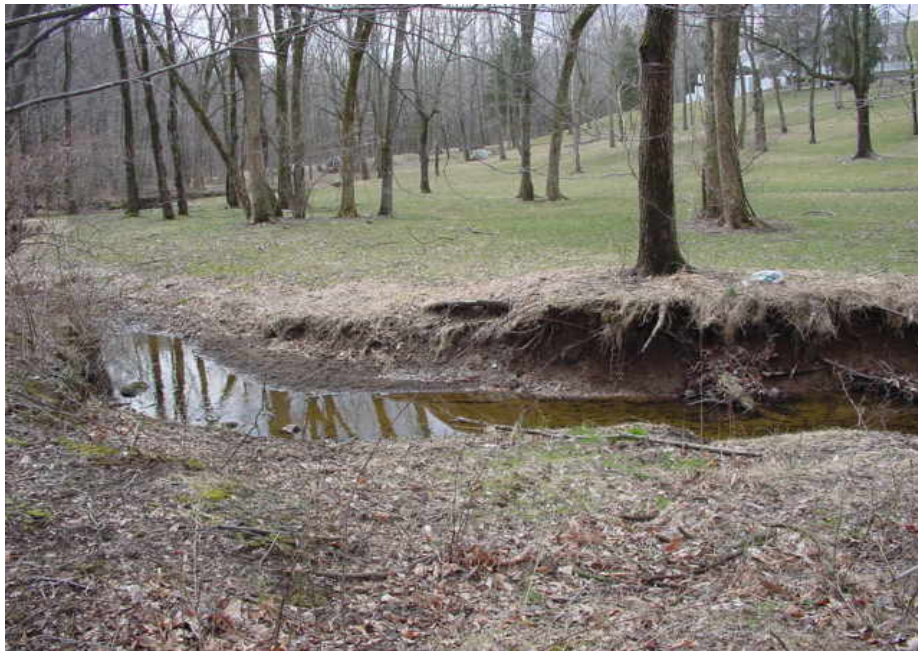
## #38: S. Branch Alexauken Creek Tributary Buffer Enhancement

### Segment CC, Reach 4

- Implement no-mow zone
- Transition to riparian buffer enhancement
- Utilize existing trees in design and augment with shrubs and herbaceous plants
